Advanced Home Inspections

RE: 321 Anywhere Ave
Melbourne , FL 32940

REPORT SUMMARY

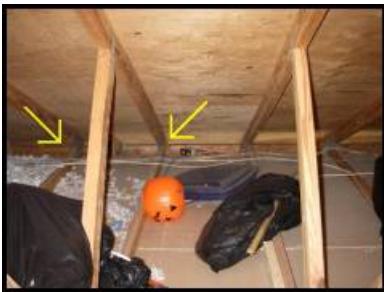
FRAMING CONDITION: Truss clips are missing on east side of garage trusses near juncture of garage and house. These missing clips are required to provide proper uplift protection and receive insurance wind mitigation discount credit.

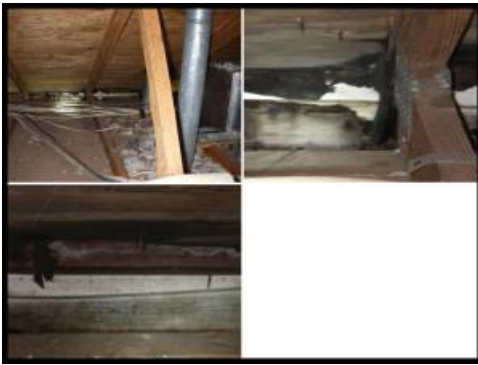
Damage to roof deck and sub-fascia are noted on west garage overhang.

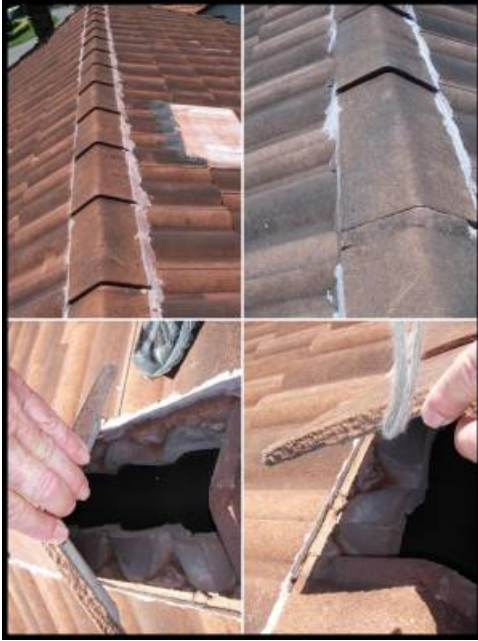
It appears the caps tile were improperly attached to field tiles with site mixed mortar, which does not provide the necessary uplift resistance. Based on Tile Roofing Institute's 'Concrete and Clay Roof Tile Installation Manual' Job proportioned mix (job site mortars) maybe used for cosmetic purposes and for wind block only.

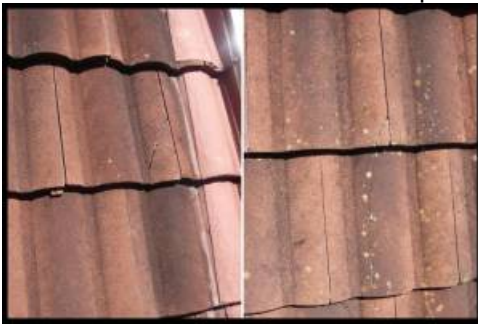
This roof installation is a sealed roof system, which the primary water protection is the roof tile and exposed flashing. The secondary water protection is the underlayment beneath the roof tiles. However, this secondary protection is not designed for an significant amount of water. There are roof tiles that are damaged and maybe allowing water penetration. Therefore, any damaged roof tiles or flashing should be repaired or replaced.

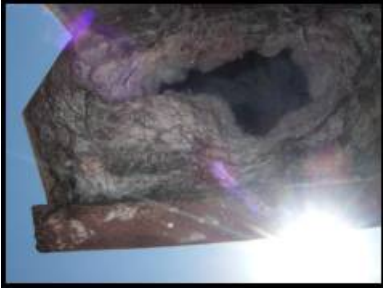
TYPE AND CONDITION: Clothes dryer vent is clogged with lint, this is a fire hazard. This condition is due to lack of sealing area where dryer vent enters roof outlet.

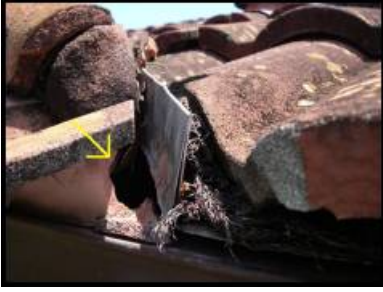
Damaged valley flashing is noted on garage west roof slope.

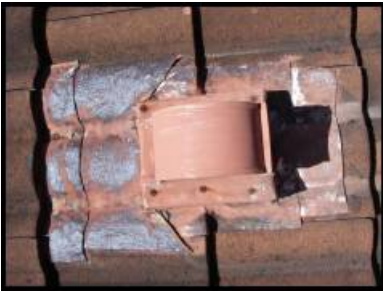
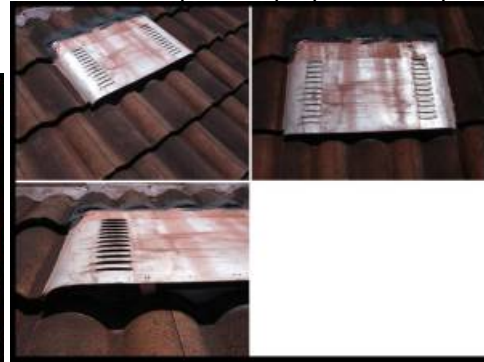
Rust damaged nails used to secure dryer outlet flashing is noted on garage east roof slope.

Attic ventilation has exposed louvers that is allowing moisture penetration. Also, the vent does not provide proper rodent protection from attic entry.

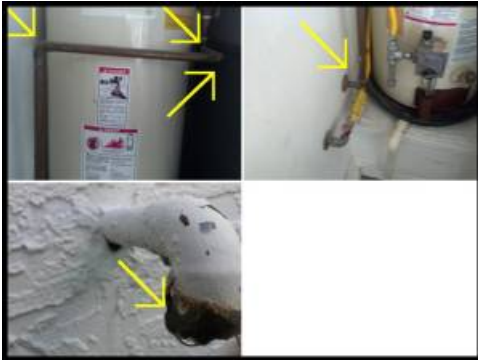
LOCATION: Garage.
TYPE: Gas.
SIZE: 40 Gallons.
MANUFACTURED DATE: 2004.
CONDITION: Temperature pressure relief valve does not meet manufacturer installation instructions, which states the drain line should have **no more than 4 elbow fittings or bends**. The purpose of this requirement, is to prevent a reduction in the discharge capacity. Recommend redirecting drain line straight down to drain pan or floor.

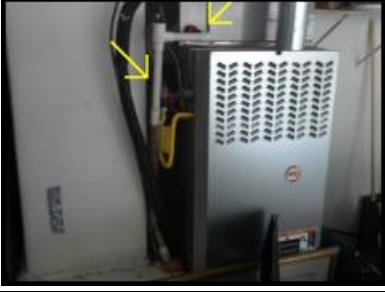
TYPE: Central Air.
MANUFACTURER: Payne.
MANUFACTURED DATE: 2009.
POWER SOURCE: 220 Volt, Electrical disconnect present.
CAPACITY OF UNIT: 4 Ton.
SEASONAL ENERGY EFFICIENCY RATING (SEER): Undetermined.
SYSTEM CONDITION: Appears serviceable.
EVAPORATING COIL: The evaporating coil is located in a cabinet above air handler and inside the supply plenum ductwork. Due to the coil's cabinet design, the coil's air intake side is not visible for inspection.
CONDENSATE LINE: At the time the existing air handler was installed the following requirement was not met. Condensation drain line is required to be thermally insulated. This is to prevent condensation from forming on pipe and dripping on to air handler stand.

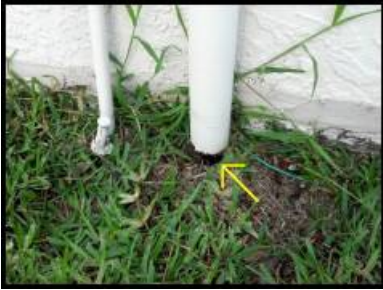
TYPE AND CONDITION: 120/240 Volt, Circuit breakers. Service conduit beneath electric meter, has rust damage at grade level, exposed electrical wire is subject to damage.

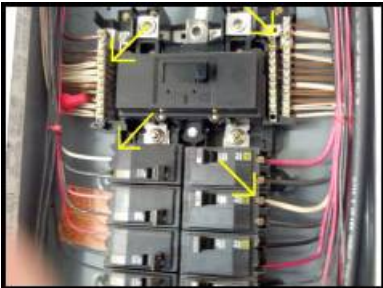
MAIN PANEL LOCATION: Garage.
PANEL RATING: Maximum panel rating is 200 Amps.
MANUFACTURER: Square D Panel.
PANEL'S CONDITIONS: Multiple neutral wires (grounded conductors) are connected under 1 lug. This condition does not meet industry standards, which requires each circuit to be isolated. If the terminal is shared with another circuit, the connection on the other (still energized) circuit will be loosened as well. Loosening of the second neutral (loss of neutral) under load is a safety hazard, and may establish an overvoltage condition on lighting and appliances if the neutral is part of a 120/240V multi-wire branch circuit. Also, the neutral assemblies are not evaluated with multiple neutral conductors in the same terminal. The requirement has generally been enforced in the past by a close review of the manufacturer markings and by NEC 110.3(b). Clause 12.3.10 of UL 67 (Panelboards) states "An individual terminal shall be provided for the connection of each branch-circuit neutral conductor." This condition can be easily corrected by re-installing individual neutral conductor under 1 terminal.

Conductors (Wires) with white insulation when used as phase (hot) conductors, they must be permanently re-identified.

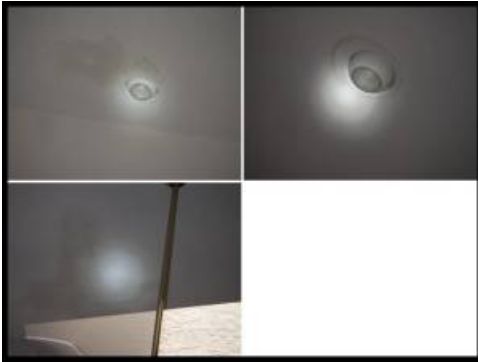
CONDITION: Moisture stains are noted, at dining room, kitchen and living room skylight. Unable to determine if active leakage exists.

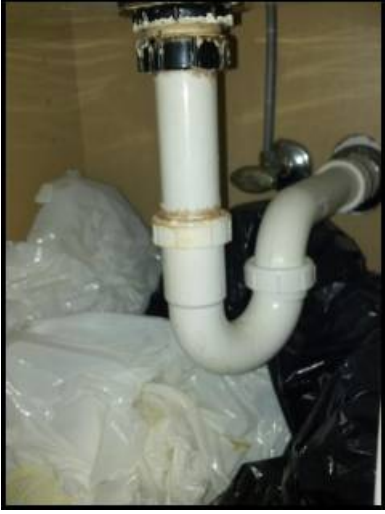
Laundry sink has drain leaks at sink connection.

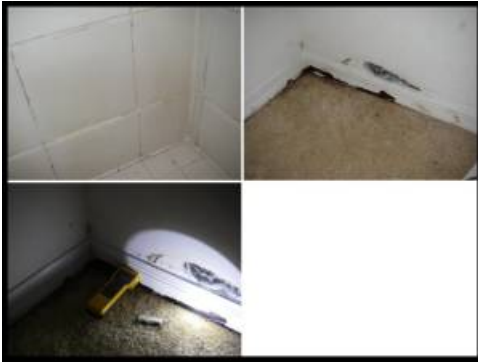
BATH LOCATION:	Master bedroom.
CONDITION OF SINK:	Faucet appears serviceable, Counters/cabinets appear serviceable.
CONDITION OF SINK DRAIN:	Drain appear serviceable.
CONDITION OF MAIN VALVES	Main valves under sink appear serviceable.
CONDITION OF TOILET:	Appears serviceable.
TUB/SHOWER PLUMBING FIXTURES:	Appears serviceable.
SHOWER HEAD & DRAIN CONDITION:	Shower head appears serviceable, Drain appears serviceable.
TUB/SHOWER AND WALLS:	During construction a shower pan is installed, when the shower floor is not recessed below the finish floor. If not installed properly or if shower pan is damaged or deteriorates, any water that penetrates behind wall and beneath floor tiles can penetrate the adjacent walls. When tested, water was noted in the rear guest bedroom closet wall. Unable to determine if there is possible hidden damage in these areas as well. The extent of the damage will become evident as soon as the tile and backing material are removed.

Moisture damaged wallboard behind tile is noted on lower portion of wall adjacent to vanity. Wallboard is soft, recommend replacing the water resistant drywall with Durarock or Wonder board, this product is durable and less susceptible to moisture damage.

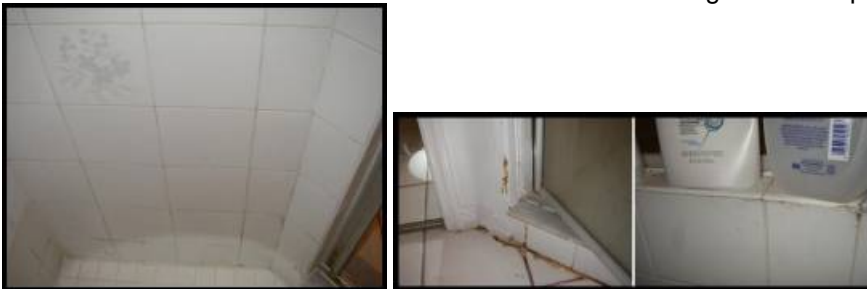
Moisture damage is noted at the wall or floor outside the shower area, which could be due to shower door missing door sweep and damaged tile grout.

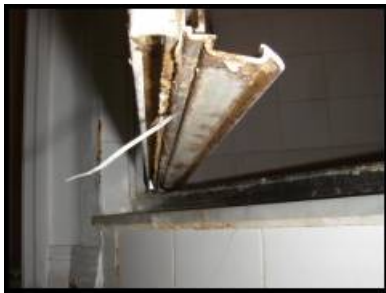
Shower door's vinyl door sweep is damaged, which is preventing a proper seal the gap between door and threshold. This condition is allowing water to splatter outside shower area.
