Advanced Home Inspections

January 16, 2007

RE: 123 Easy St.
Melbourne, FL 32940

REPORT SUMMARY

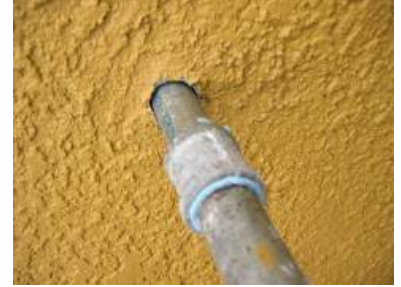
Caulking gas pipe penetration, on right side wall, is recommended to prevent water penetration.

Paint touch up is needed on left side wall plumbing penetrations.

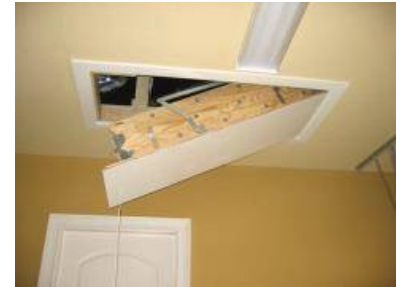
Attic access ladder covers, in both garages, do not close properly. Covers will only partially close.

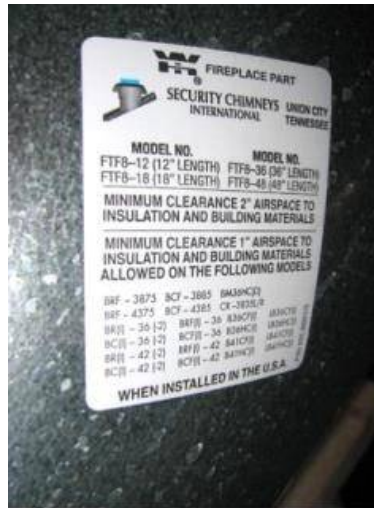
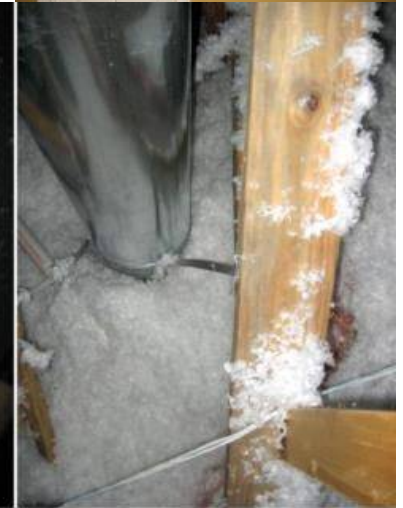
Inadequate clearance between the chimney's vent pipe and the blown in insulation. Based on information stamped on the chimney's flue pipe, there should be a minimum of 1" clearance between the vent pipe and any insulation material. Although, the insulation maybe fire resistance, the required clearance is actually a required air space. This allows dilution of the heated air and a rapid drop in temperature. When the insulation is placed against the chimney's vent pipe, the insulation captures the heat. This allows the temperature to increase and hold while traveling laterally to combustible materials that may or may not have been outside the minimum clearance. In time there maybe ignition of this material (other than the insulation).

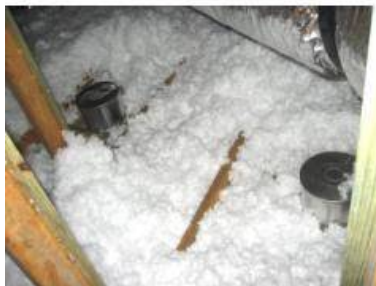
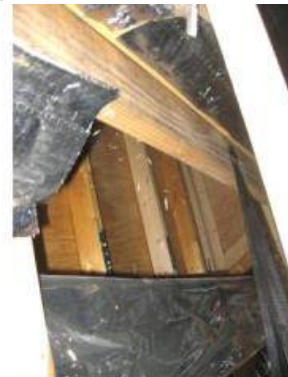
Insulation has been disturbed and good coverage is no longer present. Some areas are missing or have a small amount of insulation and no longer meet the required minimum R-19 insulation rating. This condition is noted in attic over butler's pantry.

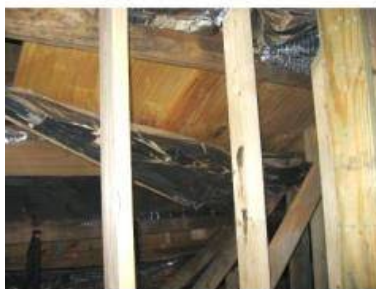
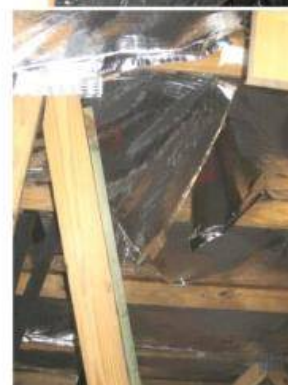
Some sections of radiant barrier are no longer properly attached to underside of roof truss, recommend reattaching. This condition is noted over front guest bedroom hall and master bedroom attic areas.

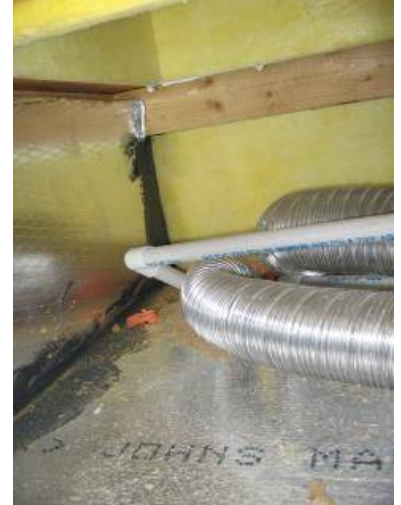
TYPE DUCTS: Return Plenum, framed box air handler sits above, this area is dirty recommend cleaning.

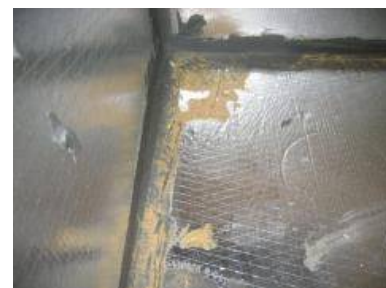
TYPE DUCTS: Return Plenum, framed box air handler sits above, this area is dirty recommend cleaning.

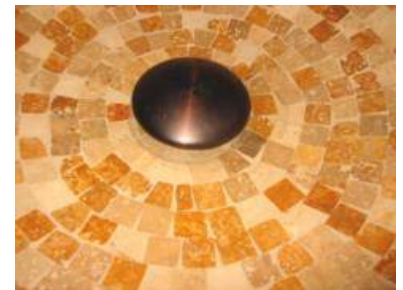
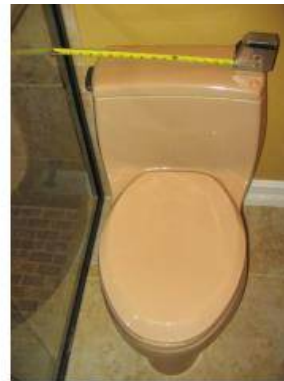
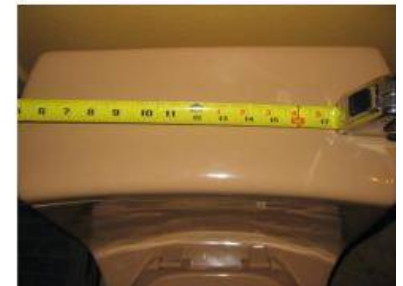
Toilet is installed too close to shower door, industry standards require a minimum clearance of 15" from center line of toilet to a wall, vanity, tub, or shower threshold. The existing installation has a 12" center line.

2004 Florida Building Code-405.3.1 Water closets, urinals, lavatories and bidets. A water closet, urinal, lavatory or bidet shall not be set closer than 15 inches (381 mm) from its center to any side wall, partition, vanity or other obstruction, or closer than 30 inches (762

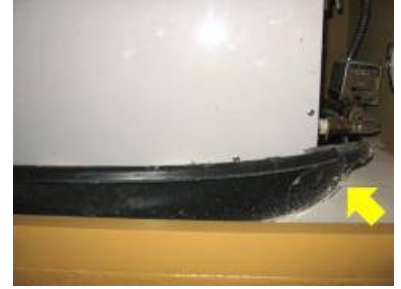
Shower's steam heater has damaged emergency drain pan, this condition could allow any water leaks to damage shower ceiling.

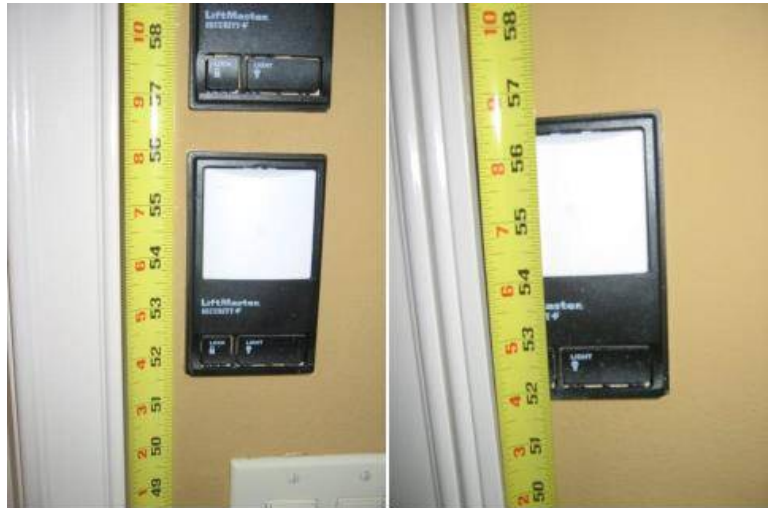
CONDITION: Garage door opener control button has been installed less than the required 5 feet above floor as required by opener manufacturer's installation instructions. This condition is noted in both garages.

Automatic reverse feature is not operational. Note: After 1993, all overhead doors should have 2 safety auto-reverse features, one is activated by the electronic light beam and the other is activated by a pressure sensor. The door's **pressure sensor** needs to be adjusted. This condition is noted on north garage double car door and south garage door.
