Advanced Home Inspections

RE: 321 Anywhere Ave
Melbourne , FL 32940

REPORT SUMMARY

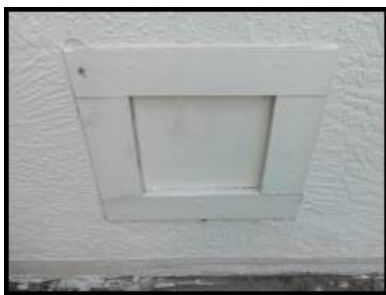
Whirlpool tub, pump and jet plumbing was observed, appears serviceable, Whirlpool was operated, but pump and jet plumbing not was observed, pump and plumbing access required cutting grout or caulk joint, this is beyond the scope of this inspection and does not meet the industry standard for readily access.
